TREATMENT OF IMPACTED DILACERATED MAXILLARY CENTRAL INCISOR : A CLINICAL CASE REPORT

Fellani Danasra Dewi¹ Endah Mardiaty²

1. Orthodontic Resident, Dentistry Faculty of Padjadjaran University
2. Senior Lecturer in Orthodontic Department, Dentistry Faculty of Padjadjaran University

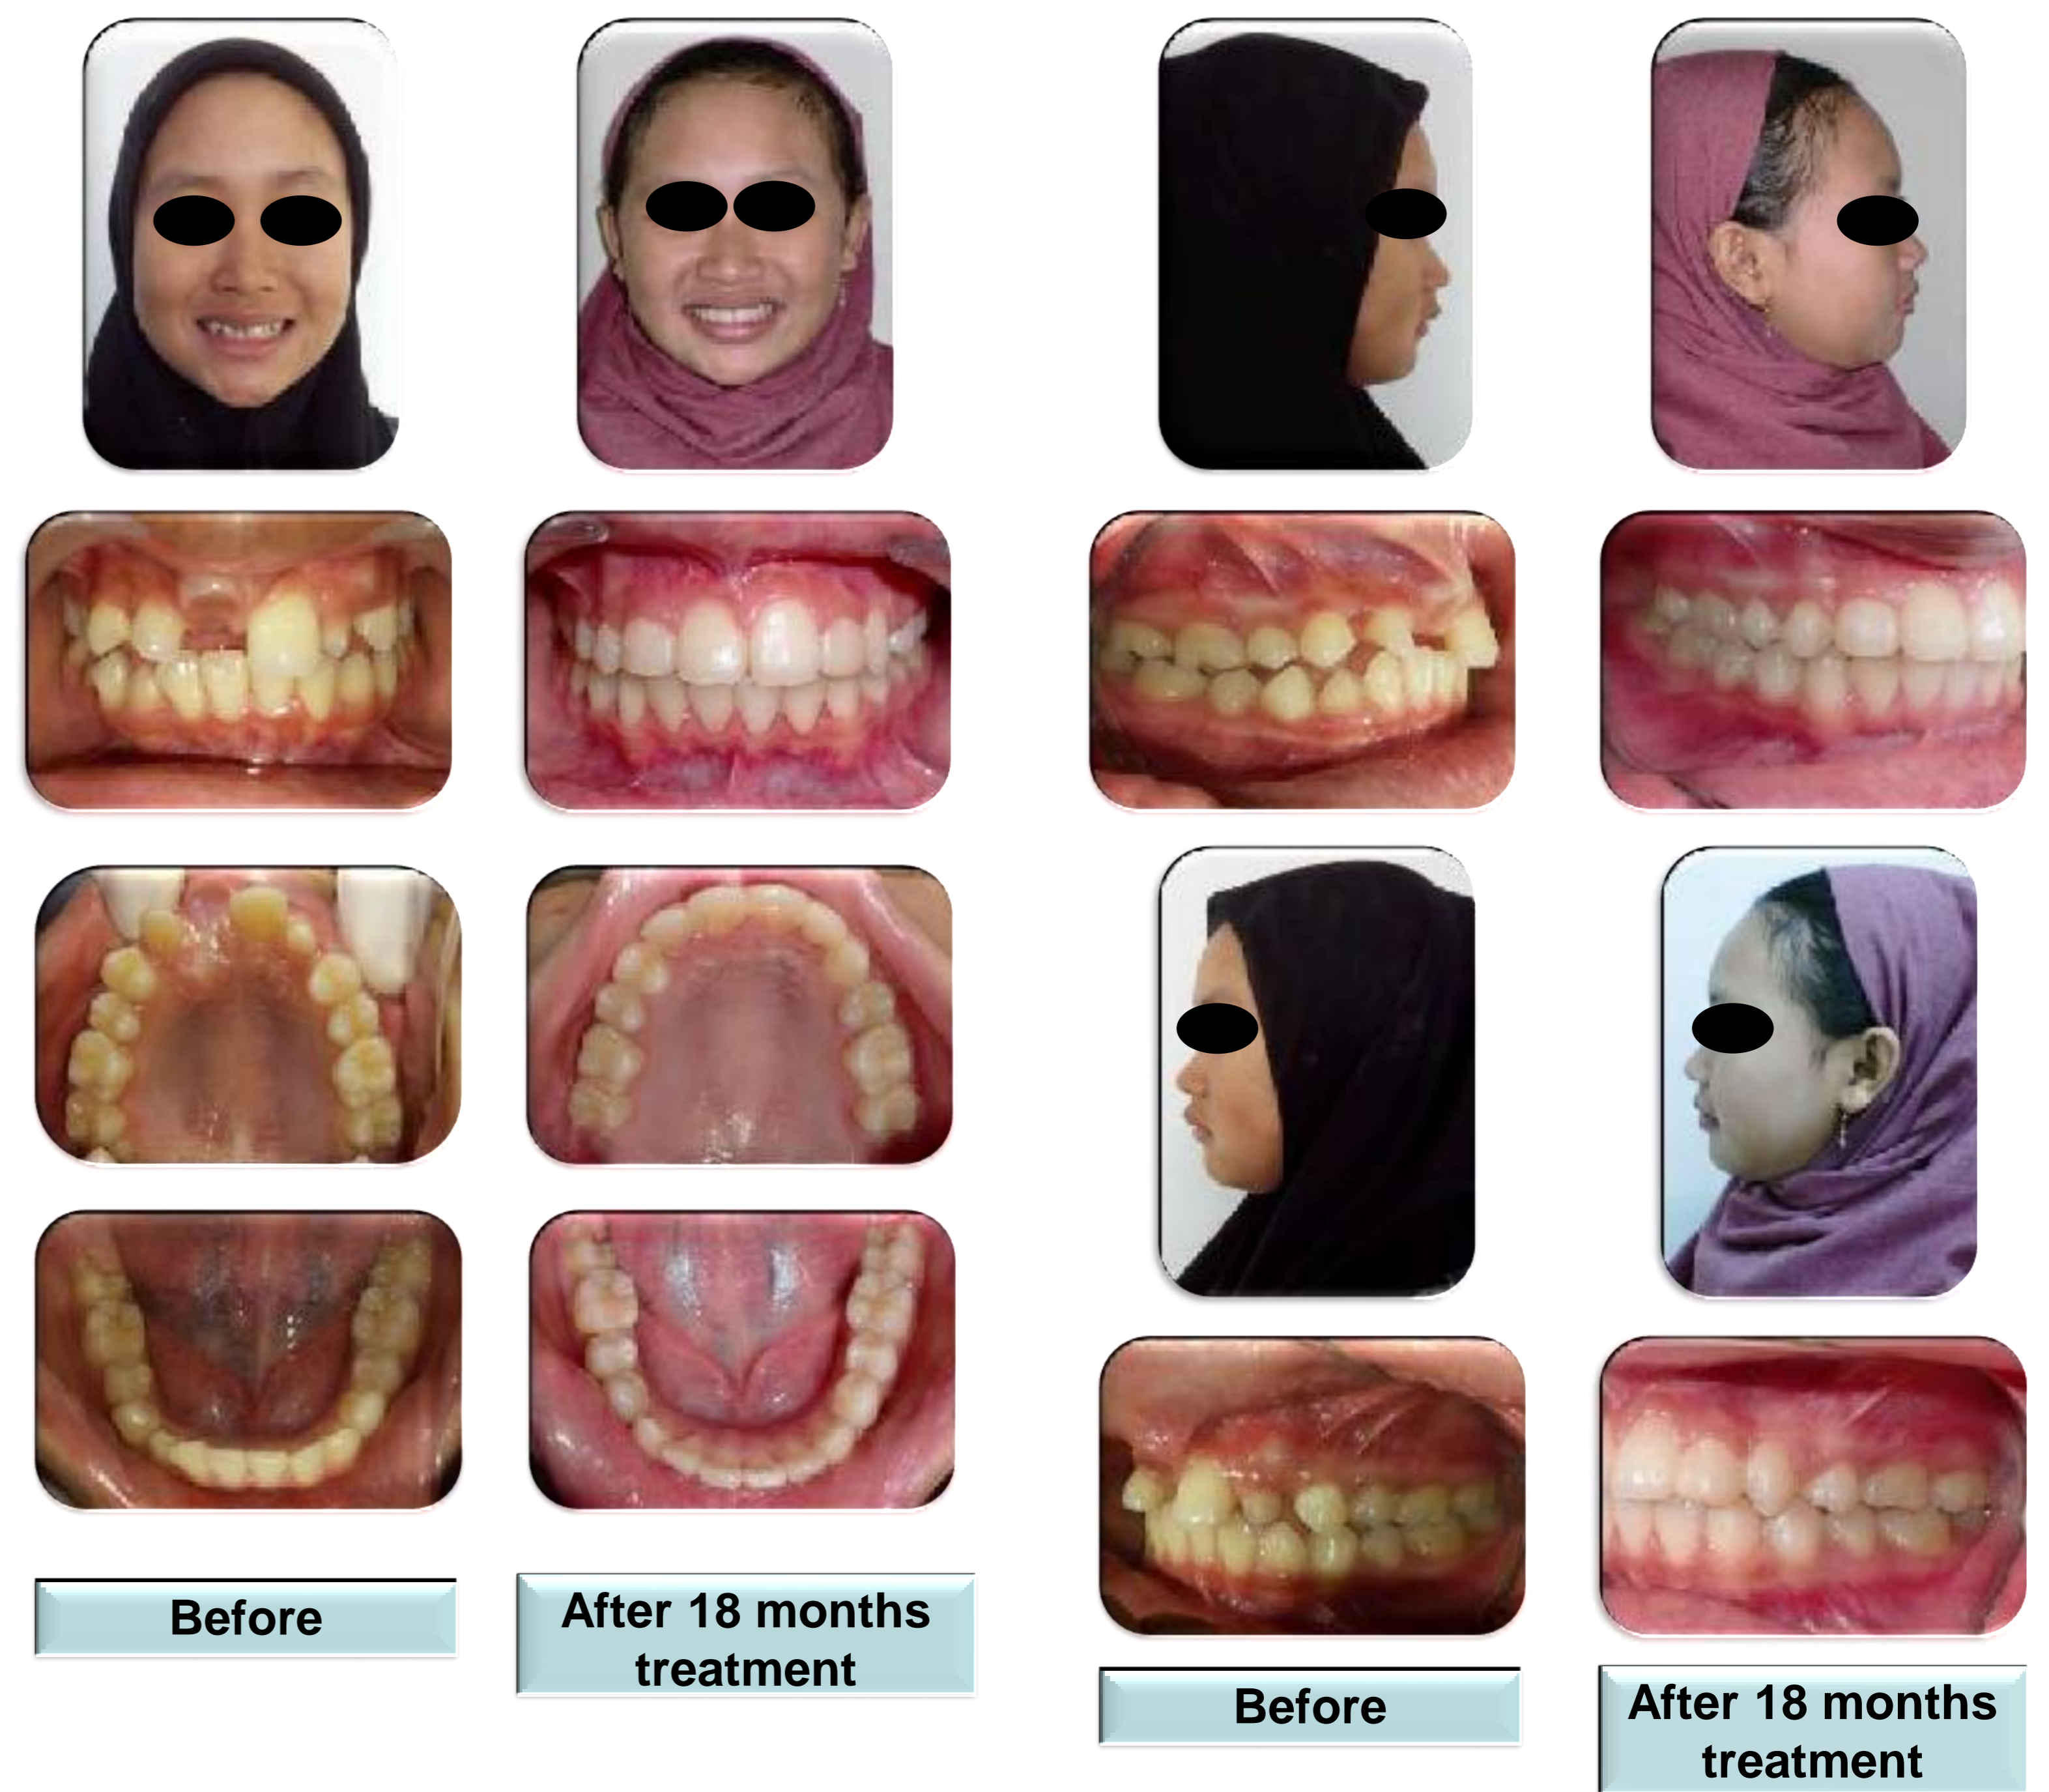
Treatment Result

- Central right incisor successfully positioned into proper alignment.
- The root was slight palpable labially underneath the alveolar mucouse.

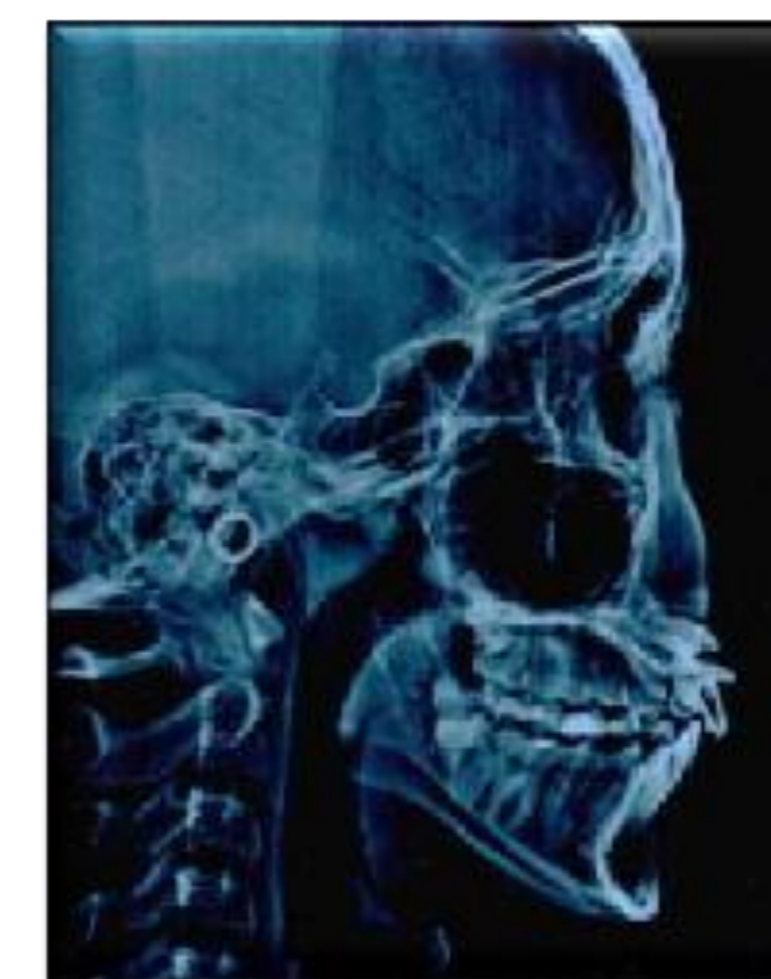
Before

RADIOGRAPHIC FINDINGS

BEFORE	AFTER
<SNA °	83	82
<SNB °	77	77
<ANB °	6	5
I-NA mm	3,5	3
<I-NA °	22	15
I-NB mm	6mm	7mm
<I-NB °	27	36
<Pg-NB mm	2mm	2mm
<I-I °	120	120
<OkI-SN °	17	28
<GoGn-SN °	41	40

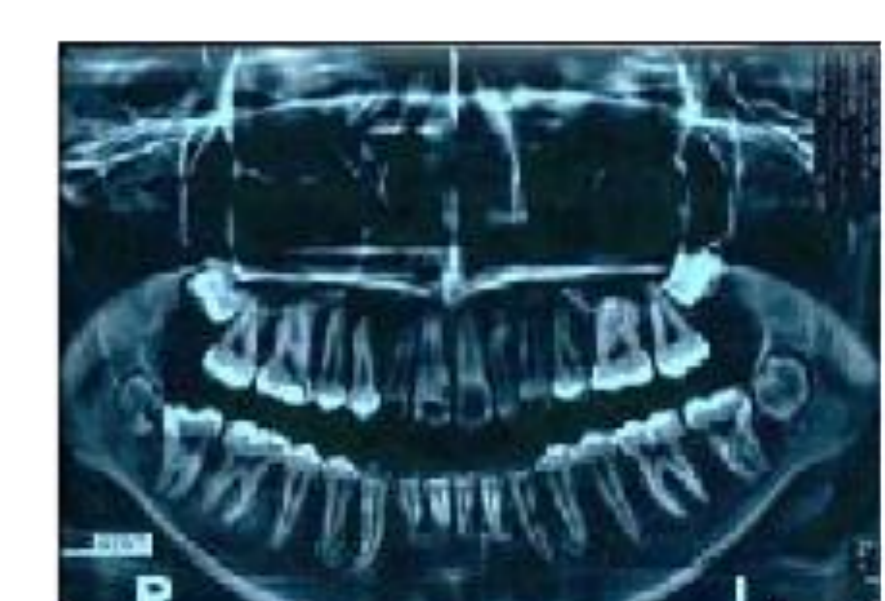
Panoramic after treatment
